Stamford Conservation Area Appraisal

Designated October 1967

Review and Extension November 2011

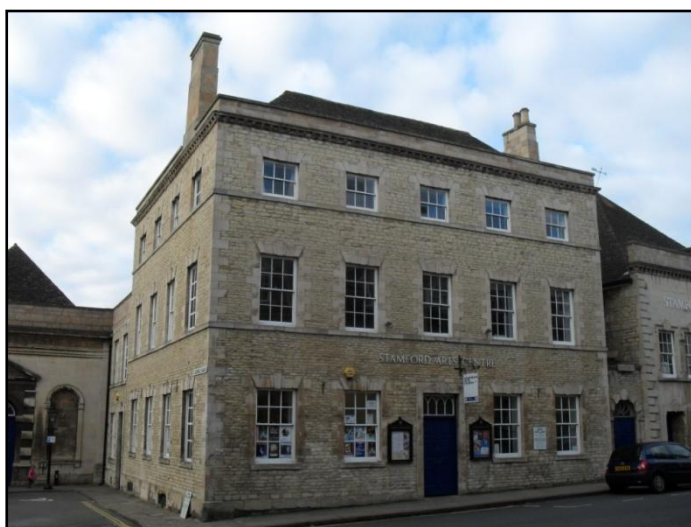
Fig. 1. Stamford Arts Centre with flush freestone dressings.

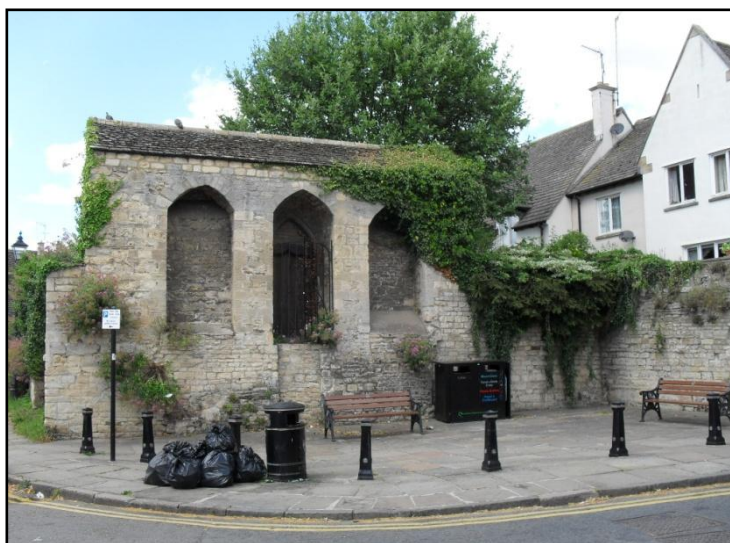
Fig.2. Remains of the Great Hall, Bath Row.

Excavations of the castle site, which was redeveloped in the 20th century, have yielded a number of finds associated with the Saxon and Norman phases of settlement. The remains of a 12th century hall, solar and undercrofts together with the remains of an earlier Saxon kiln and pottery sherds were found on the site of the bailey.

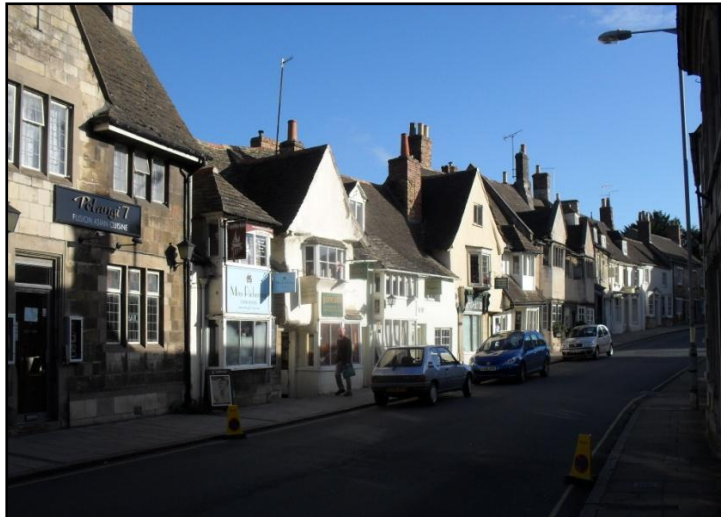
Fig. 3. Medieval buildings on the north side of St Paul's Street

The character of the town began to change as stone began to replace timber in the construction of domestic buildings. Merchants built large stone houses with vaulted undercrofts which had independent access from the street where goods were traded, No. 13 St Mary's Hill is a surviving example. Large town houses with communal open halls, some with storeyed cross gables, began to be built in the 13th century, examples of which can be seen on the north side of St Paul's Street. The churches were also rebuilt and embellished; the

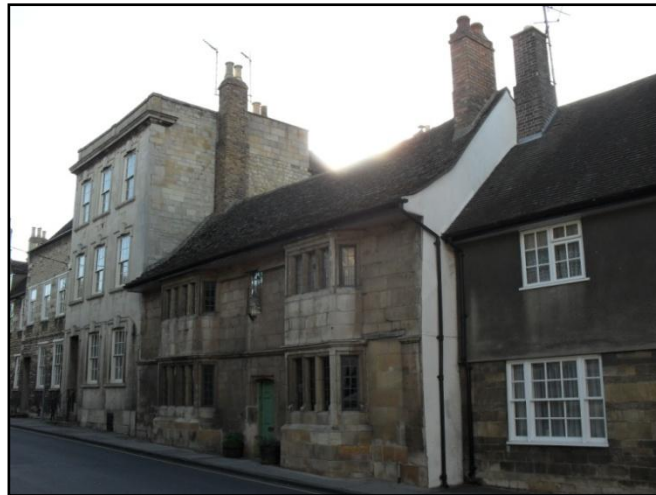
Fig. 5. No. 32 St Paul's Street.

The character of the town began to change in the 17th -18th centuries; formerly derelict sites were redeveloped and timber framed buildings were re-faced with stone or laths and plaster to cover the exposed woodwork and Collyweston slates replaced thatched roofs. The Stamford Vernacular style evolved and was the dominant style until the late 17th century. The facades were marked by bays which extended up each floor, sometimes finishing below the eaves but usually running up into the gable ends which have finials and kneelers often decorated with a date slab. Examples can be seen throughout the medieval core and include Nos. 32 Broad Street, 12 and 32 St Paul's Street.

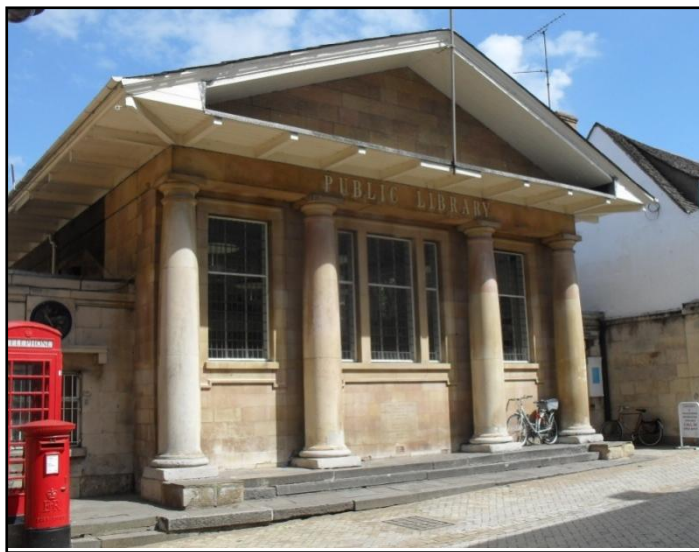
Fig. 6. The portico entrance to the shambles on High Street, converted to a library in 1906.

A number of civic improvements were undertaken during the 19th century; a portico was built in High Street as the entrance to the shambles, the new corn exchange was opened on Broad Street in 1839 and St Michael's Church, which had collapsed in 1832, was rebuilt in the Early English Gothic style. A number of schools were established in the town following the Education Act of 1870; Browne's School on All Saints' Street and a

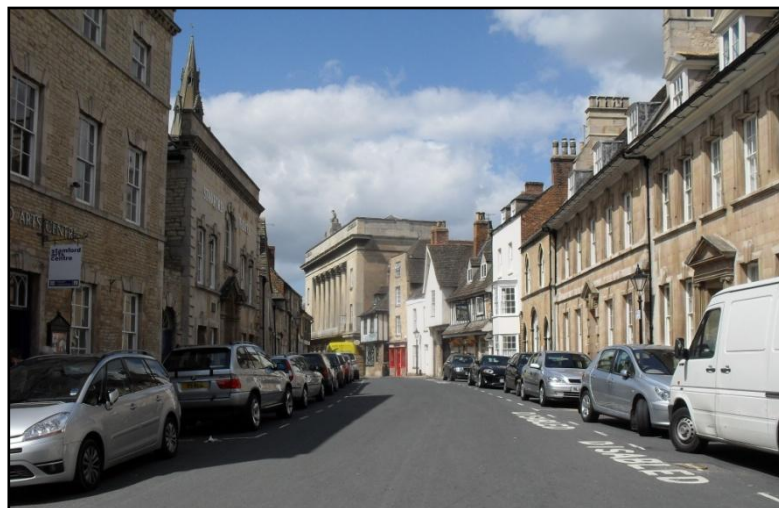
Fig. 12. Western view along St Mary's Street with the Stamford Hotel on the right.

- The former Stamford Hotel, begun in 1810, is a prominent landmark in western views along the street due to its large scale and the statue of Justice which stands on top. The spire of St Mary's Church is visible rising above the buildings on the south side. To the west of the junction with St Mary's Hill the view terminates with the façade of No. 8 Sheep Market. The mature trees on St Peter's Hill are visible above the building line which softens the urban character of the town centre.

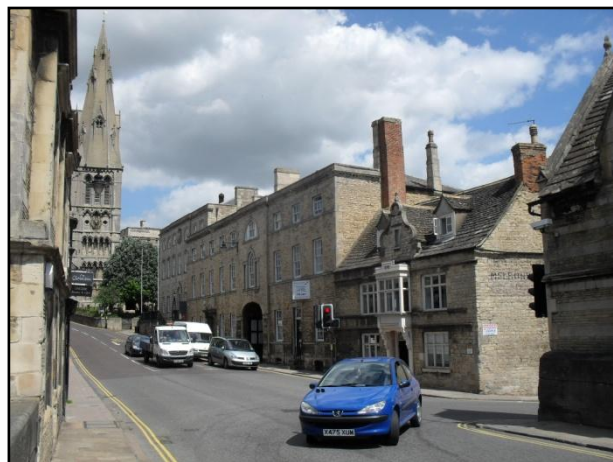
Fig. 13. East side of St Mary's Hill.

- There are attractive examples of 19th century shop fronts; No. 11 has an early 19th century shop front, Nos. 14 -15 have late

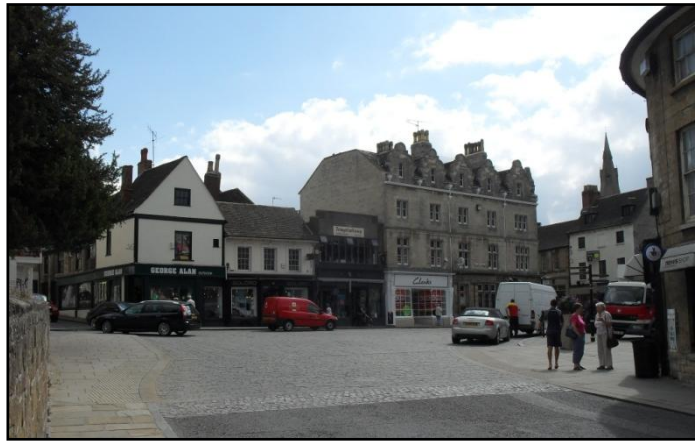
Fig. 14. East side of Red Lion Square.

- Originated as a market place during the Danish occupation. It has a vibrant commercial character.
- The buildings on the west side and south sides are "L" shaped in plan form with the open square in front and All Saints' Church encloses the north side.
- The broad junctions formed by the confluence of All Saints' Place, All Saints' Street and Scotgate contribute to the open character.
- The square is dominated by All Saints' Church which stands to the north and is complemented by the more modest St John's located at its south east corner.
- The buildings are generally large scale with wide frontages, comprising of three storeys on the east side and two and three storeys on the west and south sides.
- The buildings on the west and south sides are Grade II listed with the exception of No. 6, originally a timber framed medieval hall dating from the 15th century which is Grade II*.

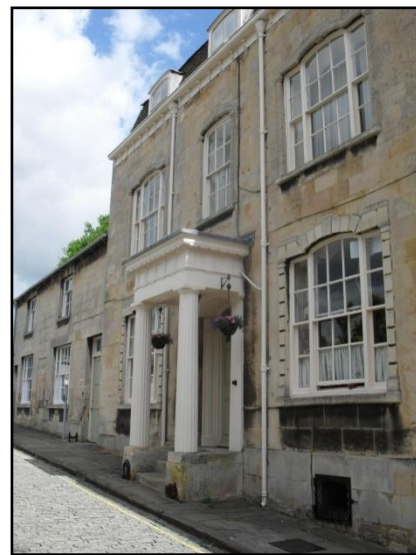
Fig. 15. Classical façade, No. 9 Barn Hill.

- The buildings are classical in style with elegantly proportioned facades and decorative details such as eaves cornices, doorcases and window surrounds. No. 13 is a prime example of the Stamford style and has retained its original ornate railings.

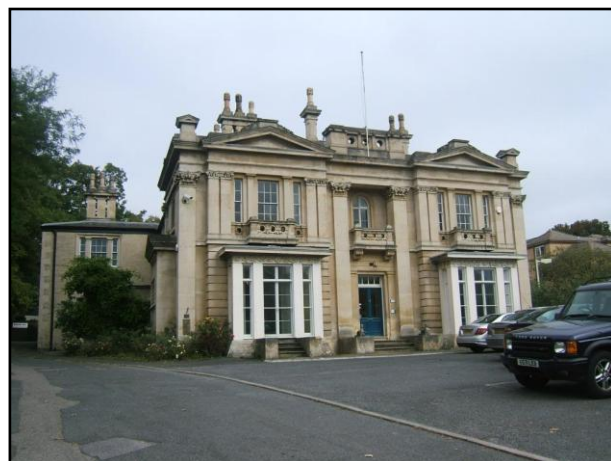
Fig. 16. Rock House and adjacent petrol station.

- The setting of Rock House is adversely affected by the adjacent petrol station which also breaks the continuity of the building frontage along the street.
- No. 48, currently occupied by Jackson Building Centre, is inconsistent with the character of the street in terms of design and materials.
- Some of the buildings have lost their traditional window designs, and in instances have replacement upvc windows which detract from the character of individual buildings and that of the street overall.
- The car park adjacent to Truesdale Hospital breaks the continuity of the frontage along the street.

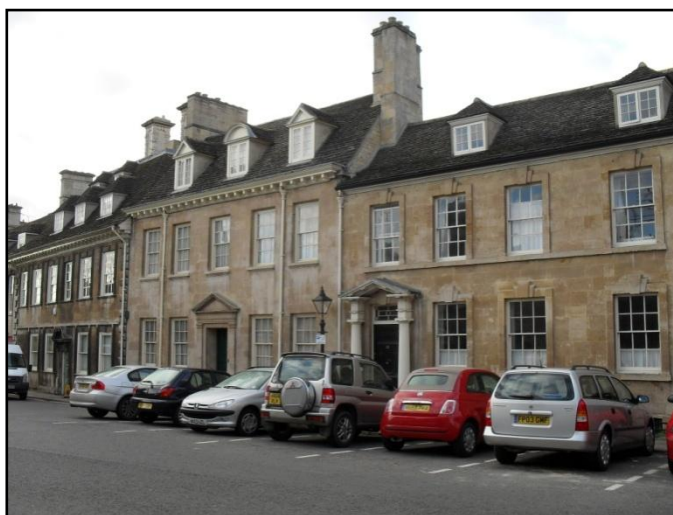
Fig.22. South side of St George's Square.

- The buildings to the north of the church are Grade II listed with wide frontages and are two storeys with attics.
- To the south the buildings have wide ashlar frontages in the Classical style and are two storeys with attics which generally date from the 18th century. There are seven Grade II* and two Grade II listed buildings. Nos.14 and 15 (Grade II*) were originally a medieval manor and incorporate medieval masonry, whilst the Assembly Rooms (Grade II*) is a single storey building with a central rusticated doorcase. The square is partially closed to the west by the forward projection of the Stamford Theatre and Arts Centre which forms a narrow junction with St Mary's Street.

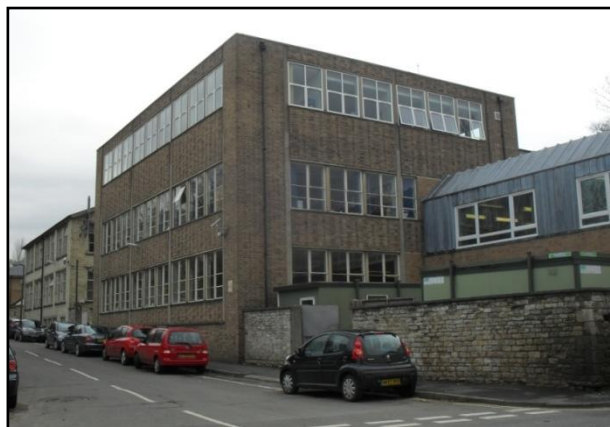
Fig. 27. Stamford School buildings on Park Lane.

- The large scale buildings associated with Stamford High School which enclose the south side of Burghley Lane and the west side of Park Lane are inconsistent with the historic context.

- The large scale three storey flat roofed extension to Stamford School located at the junction with Park Lane and Barnack Road is at variance with the quality of the traditional buildings and detracts from the views along the street.

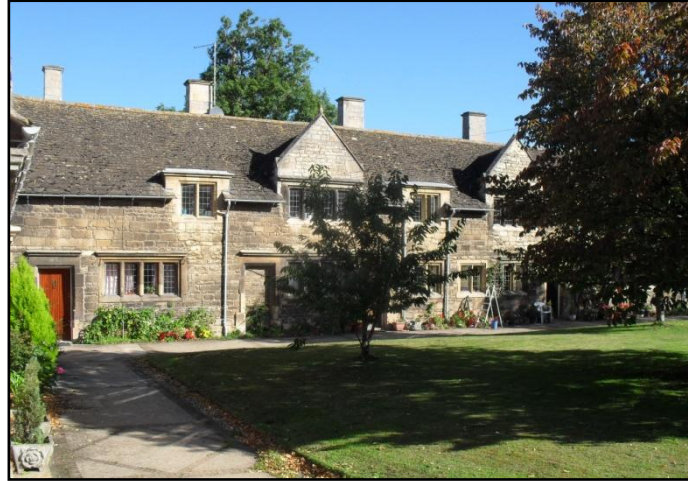
Fig. 28. Lord Burghley's Hospital.

- The broad width of the road confers an open character.
- The south side is enclosed by the rear ranges and mews buildings to The George Hotel, whilst the north side is more open as Lord Burghley's Hospital is set back from the highway and arranged around a central grassed courtyard. The hotel and almshouses are Grade II* listed and therefore highly significant. The almshouses were founded by William Cecil in 1597, but the central range dates from the 17th century and was altered in 1964, with 18th century chimney stacks which are a prominent feature in the views along the street.

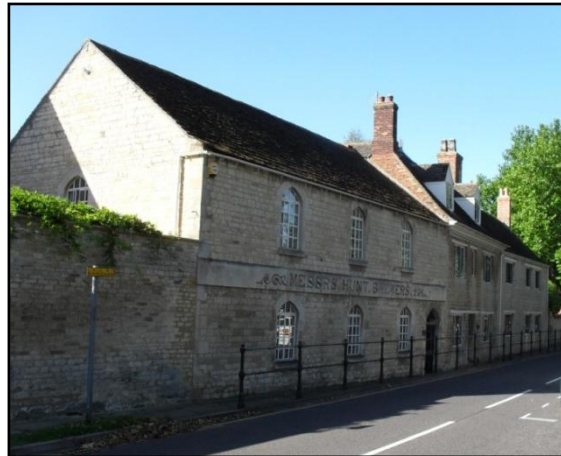
Fig. 29. Former brewery buildings on Water Street.

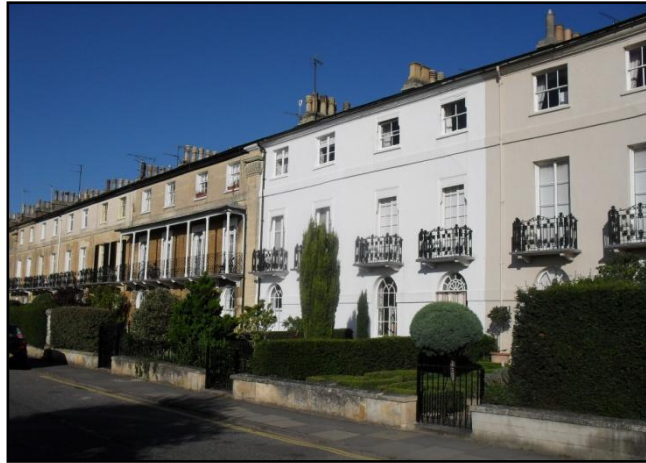
Fig. 30. Rutland Terrace.

The buildings have a more unified character in terms of design as the houses were built following the enclosure of the open fields and were therefore built as planned developments rather than on a piecemeal basis; Rutland Terrace is the most notable example.

The buildings are mainly constructed of stone, either coursed rubble or ashlar for the elegant terraces. There are examples of modest but attractive brick buildings on Adelaide Street some of which have decorative stone detailing.

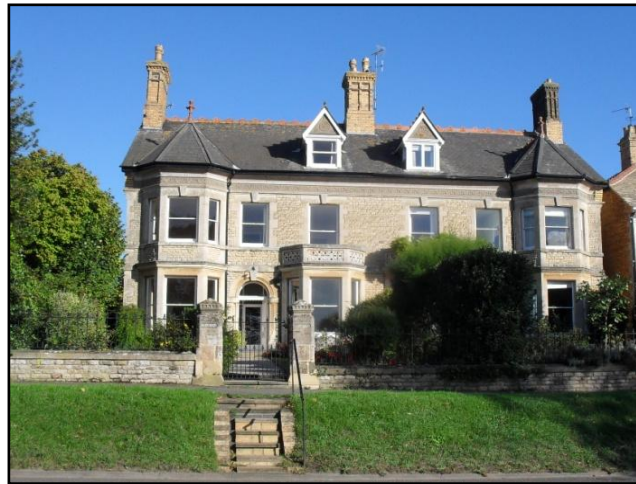
Fig. 31. Example of late Victorian houses on Tinwell Road.

- The buildings are mainly constructed of brick with the exception of No. 8, No. 1 and the first two storeys of No. 4 which are constructed of coursed rubble masonry. No. 8 is a Grade II listed building dating from the mid 18th century.
- The north side is characterised by large pairs of Victorian stone built semi-detached and detached villas in the Gothic or Tudoresque style. They are elevated above the footway, and stand within modest gardens enclosed by boundary walls with gate piers which form a continuous building line along the street.
- The south side comprises of attractive smaller scale brick terraces with bay windows, some of which have decorative terracotta detailing.
- The footway on the north side is elevated above the highway with a grass verge planted with mature trees.
- There are attractive views across the Welland Valley from the western end of the road to the Bottle

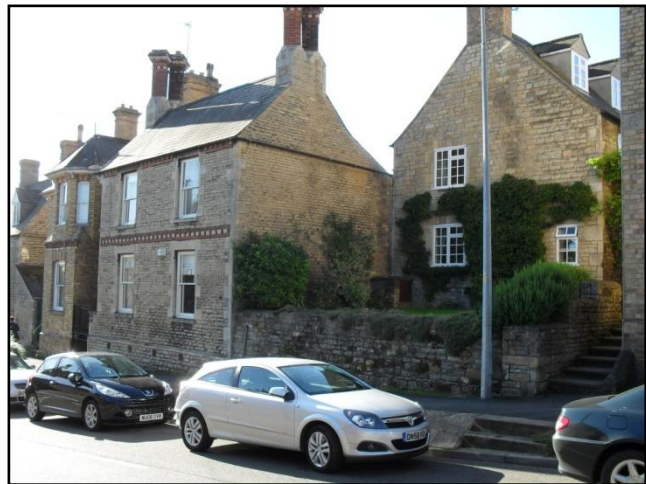
Fig. 32. Empingham Road.

- The south side comprises of a group of attractive brick and stone buildings with decorative brick detailing aligned to the rear of the footway. Nos. 20-34 is a terrace of small attractive cottages set back from the footway with small front gardens, some of which have retained their original features.
